MISTAKES AND DEFECTS IN USING GEOSYNTHETICS IN CONSTRUCTION INDUSTRY

GS Reinforced Structures In Alpine Regions - case studies

A.Nancey – TenCate Geosynthetics Europe

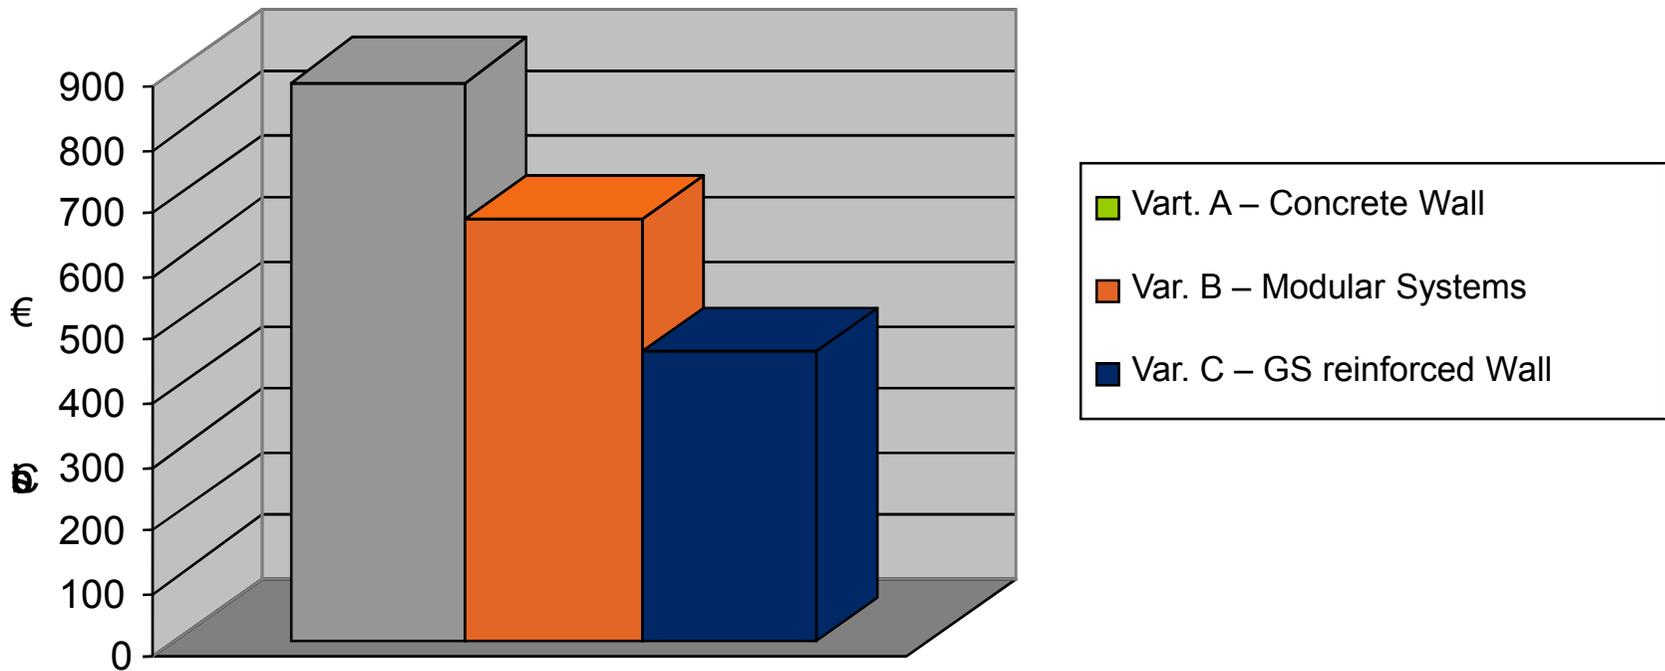
Comparison of Systems– TU Graz - Costs € / m² frontview

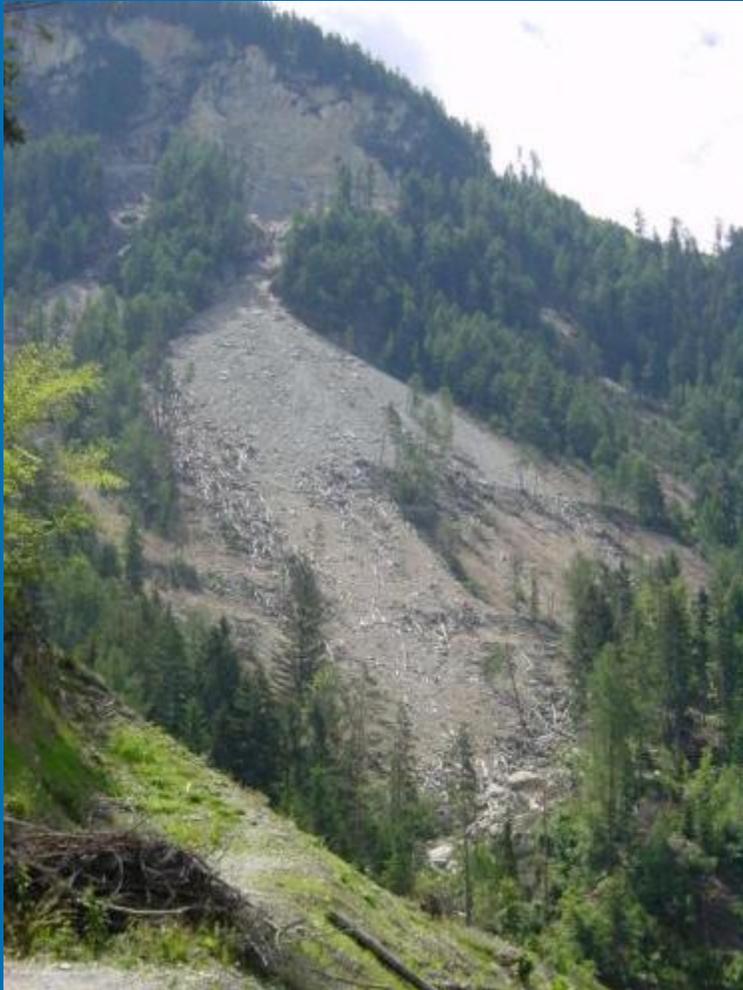
Case Study - Eiblschrofen

- 2 Protectiondams:
 - 25m height
 - Basis 80m
- 180.000m³
- construction < 2 month
- WLV Tirol, TU Wien, ILF
- System polyslope S
 - Distance of layers 50 cm
 - 100 kN/m tensile strength
 - Anchor length 6,0m

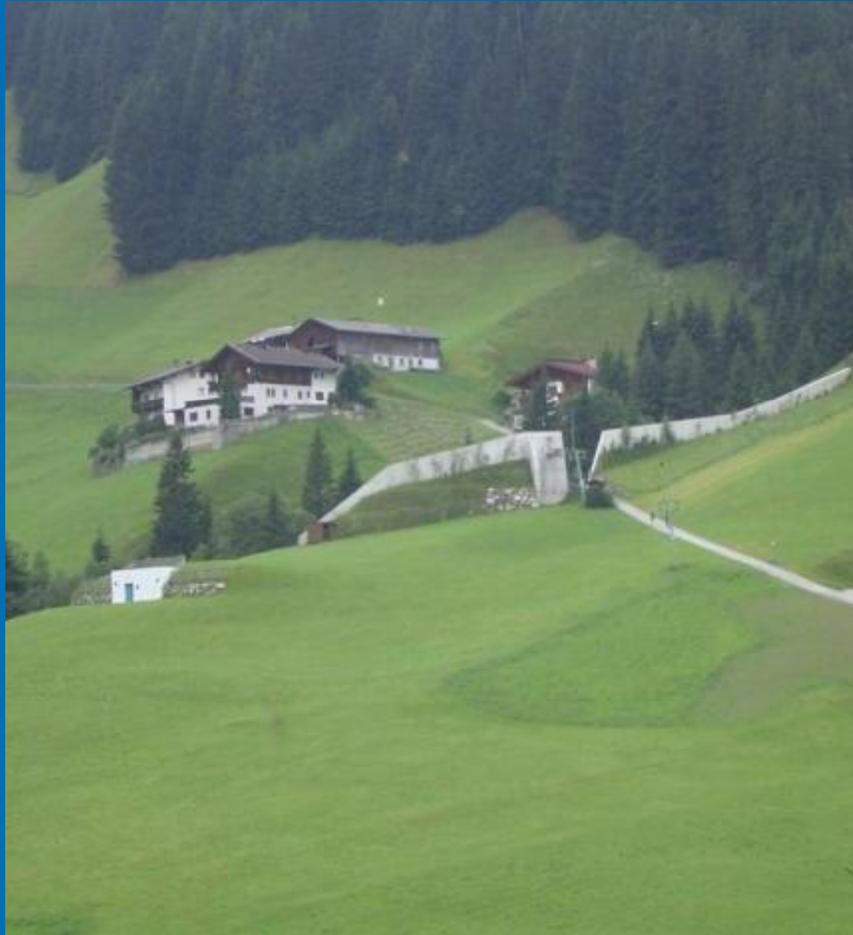
Case Study – Avalanche Protection Lanersbach

- Height 10 m, 60°
- Statically independent Concrete Wall
- System polyslope S
 - Layer distance 50 cm
 - Tensile strength 50 kN/m

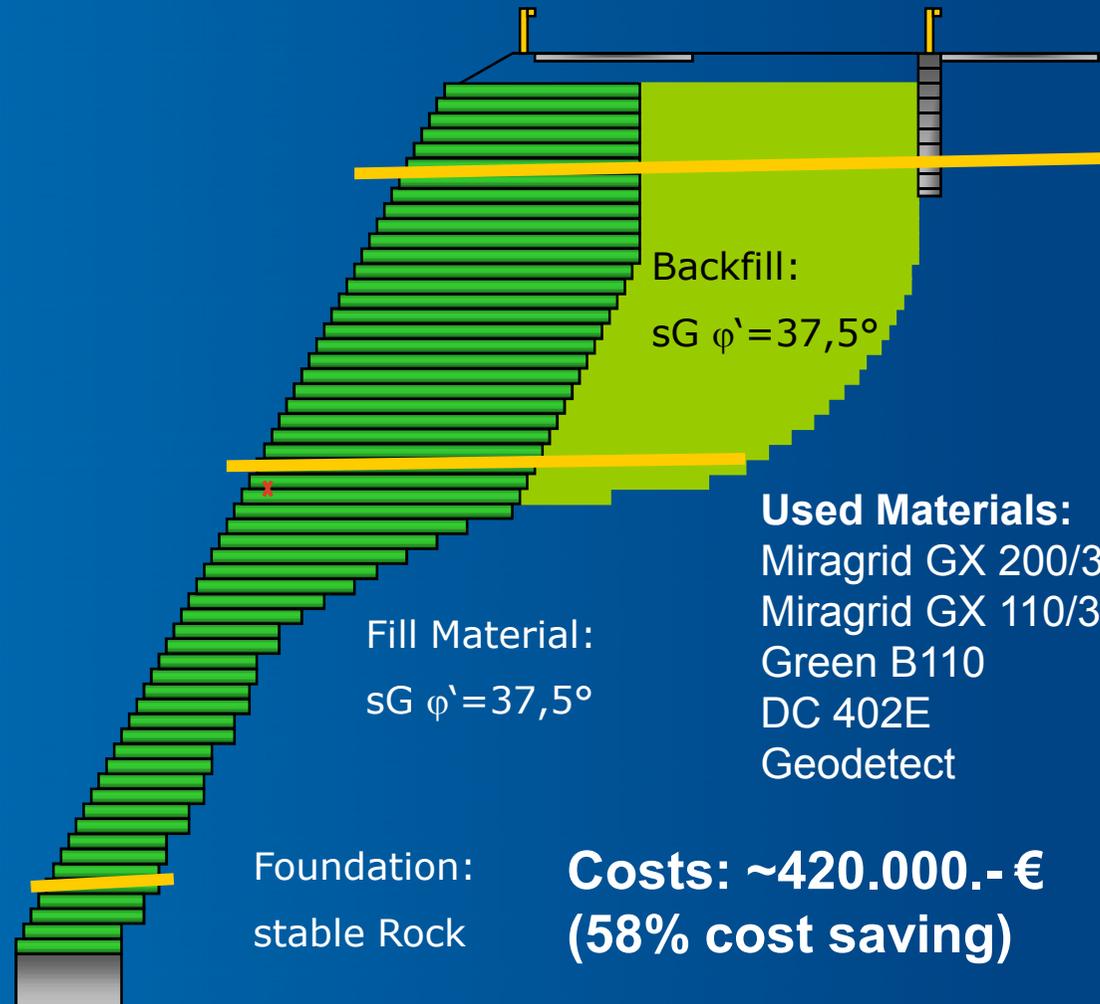
Case Study Rodlau – Option 2

Object: GS-reinforced steep slope (64°) with a height of 30m

System *Polyslope S'*

Used Materials:

- Miragrid GX 200/30
- Miragrid GX 110/30
- Green B110
- DC 402E
- Geodetect

Foundation:
stable Rock

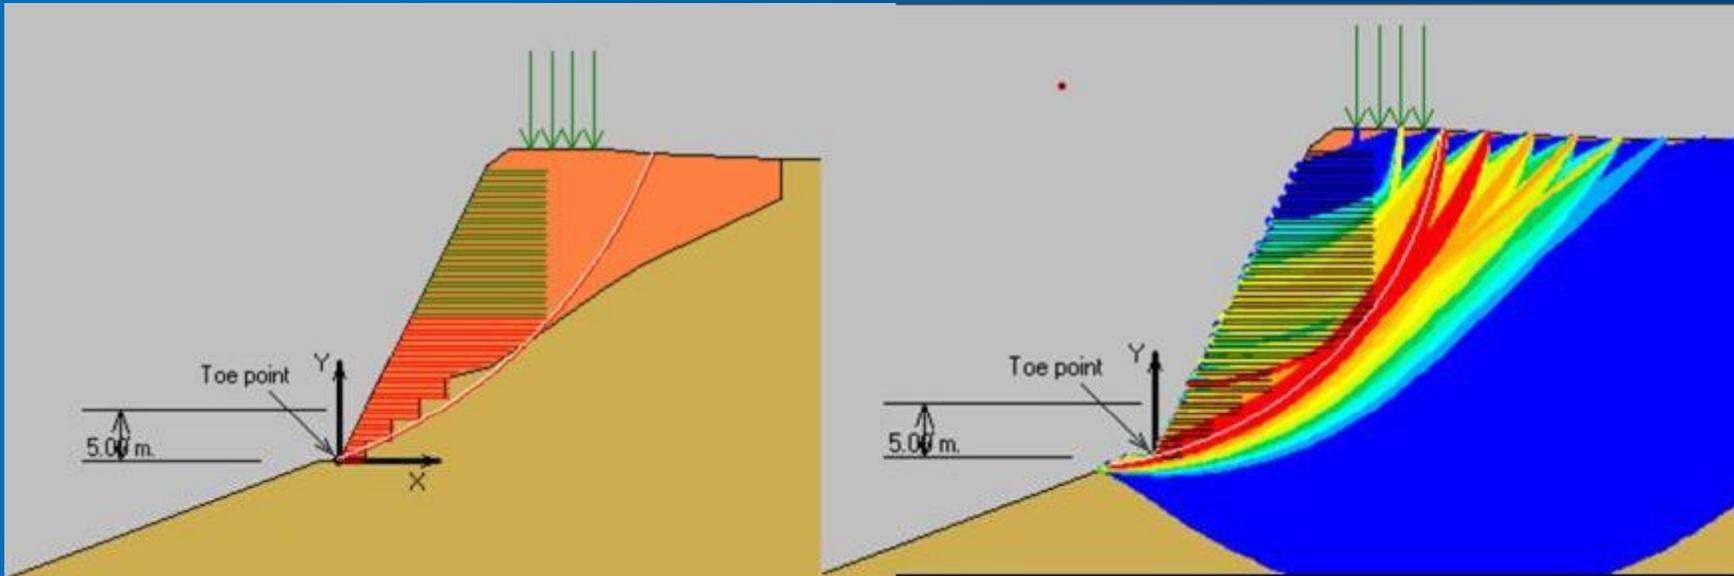
Case Study Rodlau – Design and System

- Design according to EBGEO
 - Internal Stability: Pull Out / Rupture
- External Stability:
 - Austrian Standard ON B 4433: Slope failure / ON B 4432: Base failure / ON B 4434: permissible earth pressure on facing

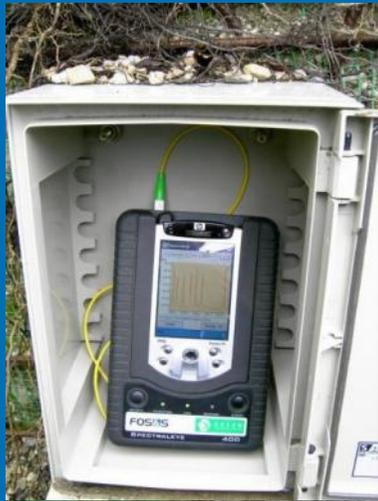
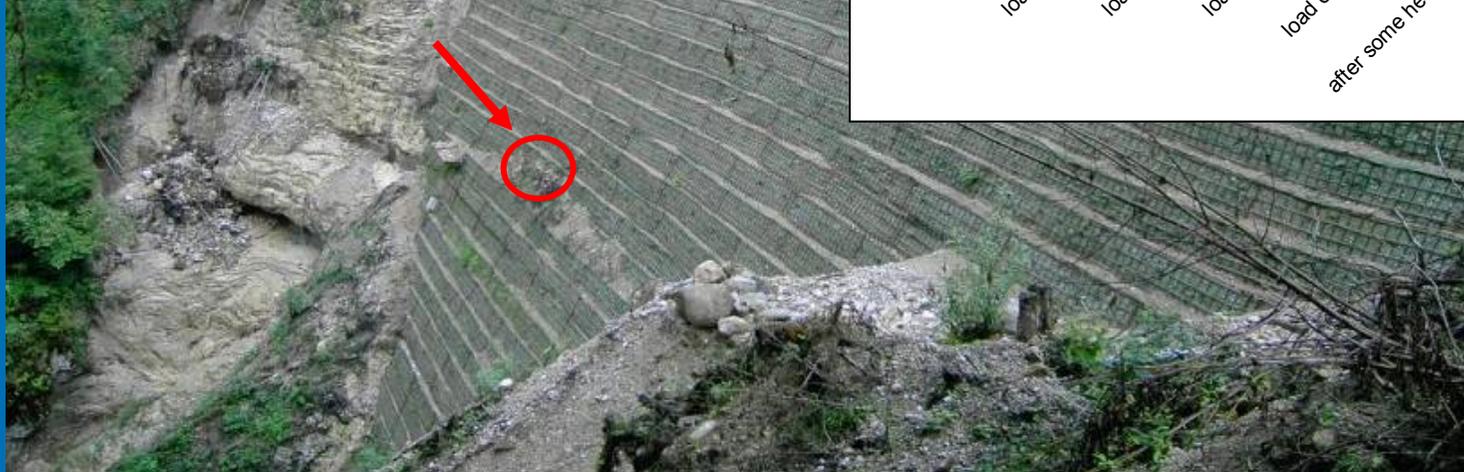
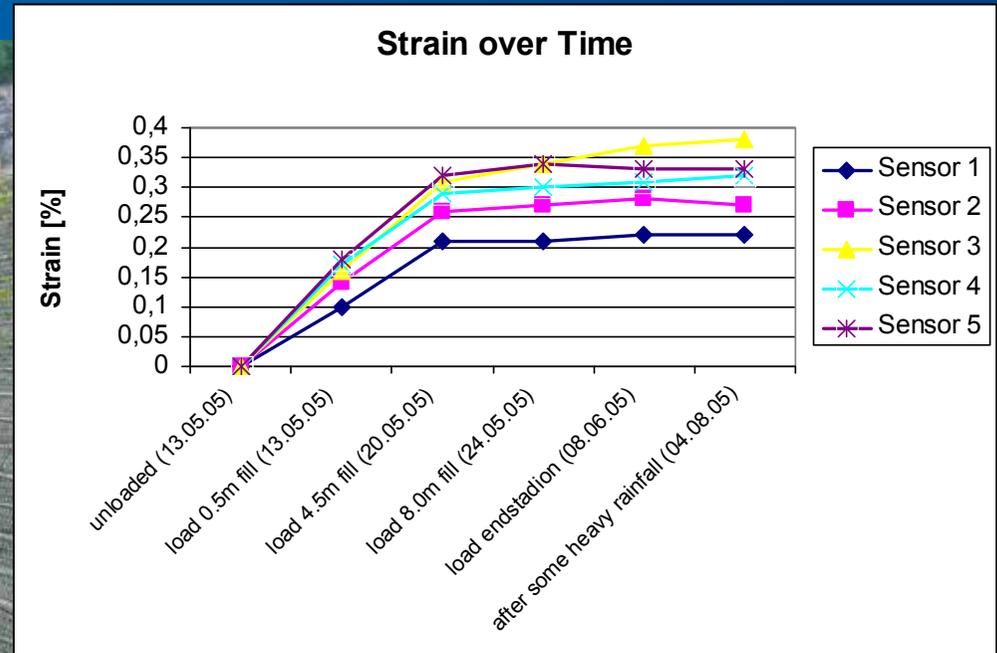
Case Study Rodlau – Deformation Measurement: GEODETECT

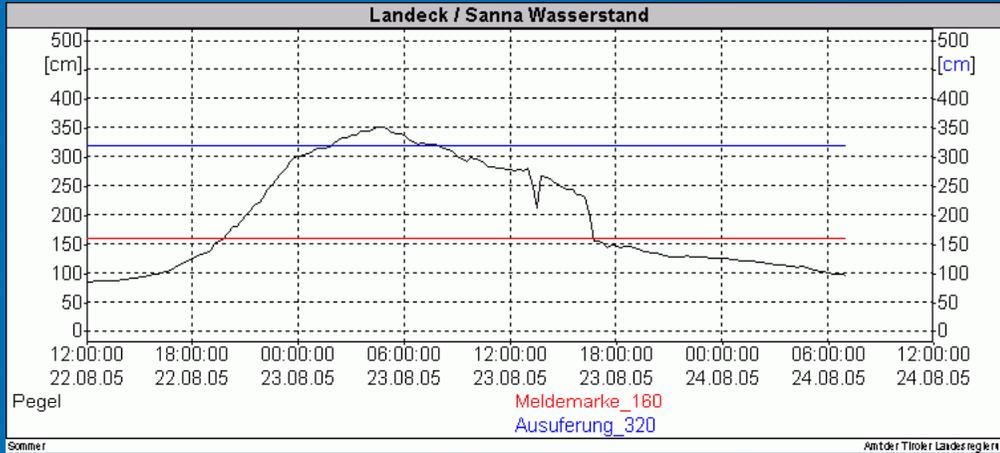
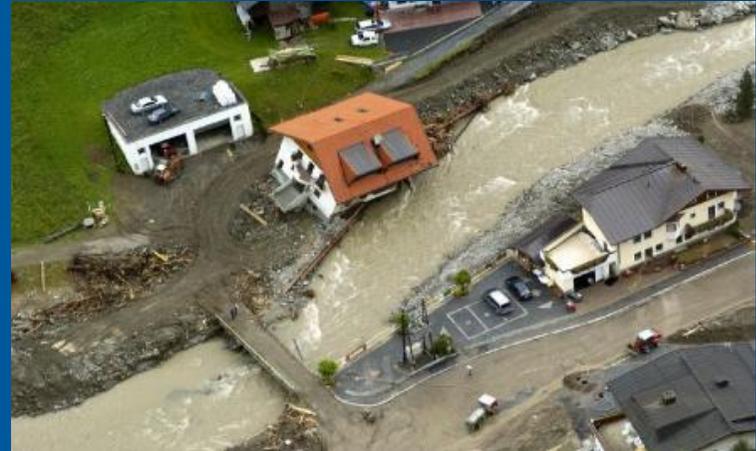
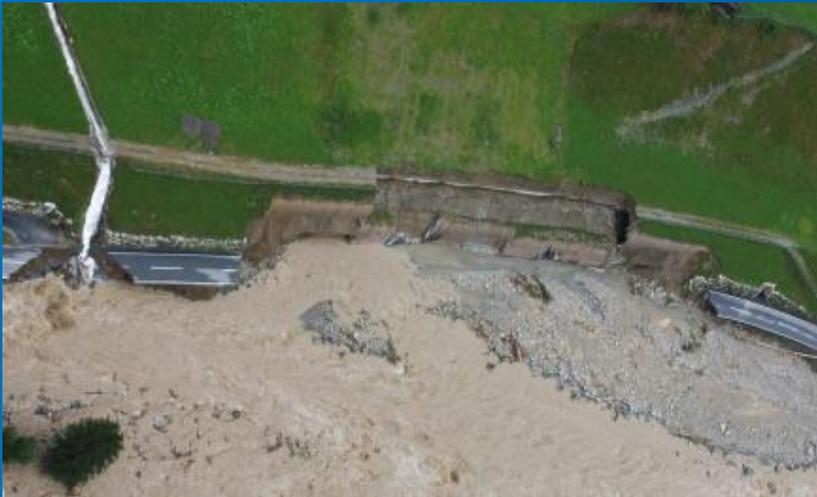
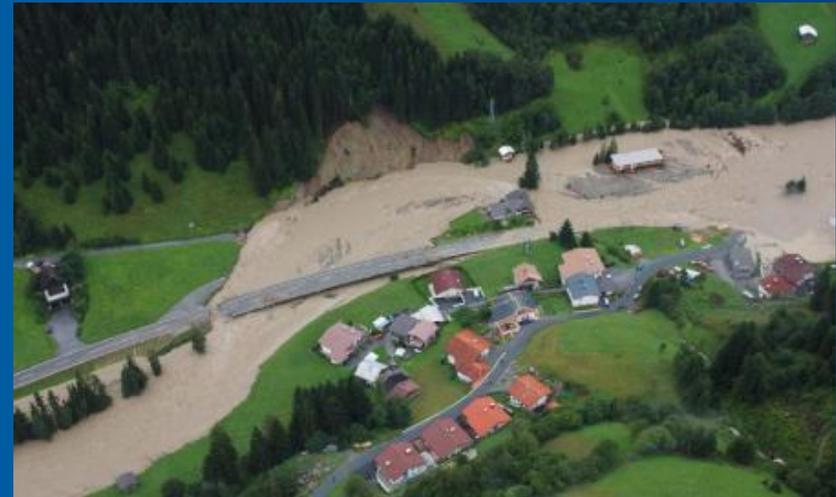
Flood Event and Failure
